NATIONAL TRANSPORTATION SAFETY BOARD

SAFETY STUDY

Emergency Evacuation of Commercial Airplanes

**NTSB/SS-00/01
PB2000-917002
Notation 7266
Adopted June 27, 2000**

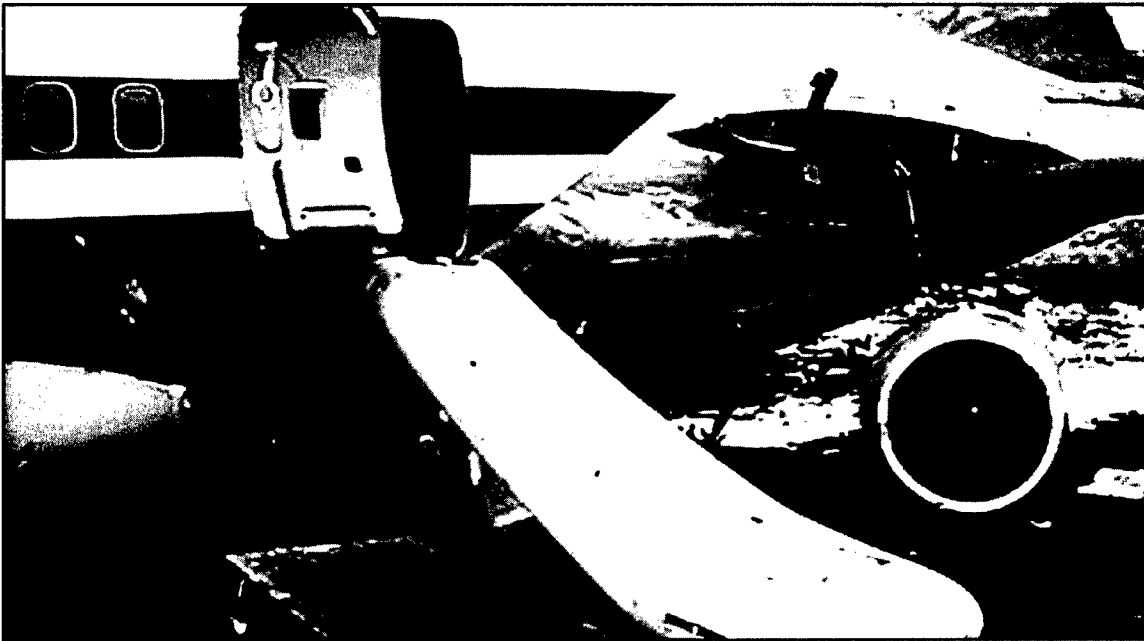
In the 727 accident in Chicago (case 9), the aircraft landed short of the runway, striking a light structure and the runway threshold. A liferaft ceiling panel door⁵³ fell open, blocking the main aisle to the L1 exit.⁵⁴ The flight attendant assigned to the L1 exit decided not to use the exit because the ceiling panel blocked access to the exit. Passengers evacuated through the R1, overwing, and L2 exits (figure 5–4).

Figure 5-4. View of a slide used in the Boeing 727 evacuation on February 9, 1998, Chicago, Illinois (case 9).

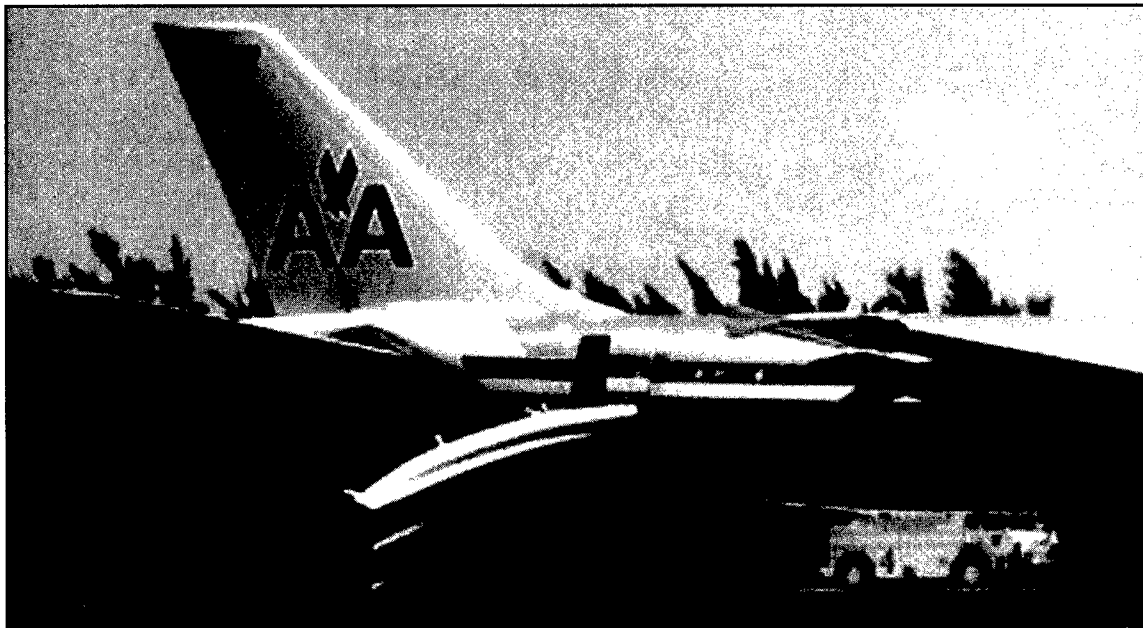
deploy the slides at R1, R2, and R4. However, there was a delay in deploying the R1 slide because of a failure of the power assist in the door. Also, the R3 door partially opened before jamming. The flight attendant tried repeatedly to open the door, but reported that he “knew [the slide] was caught up” in the pack. Postincident testing conducted by the Safety Board indicated that the malfunction might have been caused by a Velcro® fastener that became hooked on a clip on the inside of the decorative cover. In addition, the slide deployed at R4 was unusable for a period of time because winds were blowing the slide against the airplane (figure 5–9). During this time, the 234 passengers were exiting from only two of the eight exits on the A300.

Figure 5–9. View of the wind's effect (25-knot gusts) on the evacuation slide used following the Airbus 300 accident on July 9, 1998, in San Juan, Puerto Rico (case 24). Passengers were able to use this exit after a person on the ground held the slide in place.
